# Restoration of Lake Furesø

## An EU's LIFE-Nature Project

Fishing of non-predatory fish and oxidation of the bottom water

Project period:  
2003 – 2006

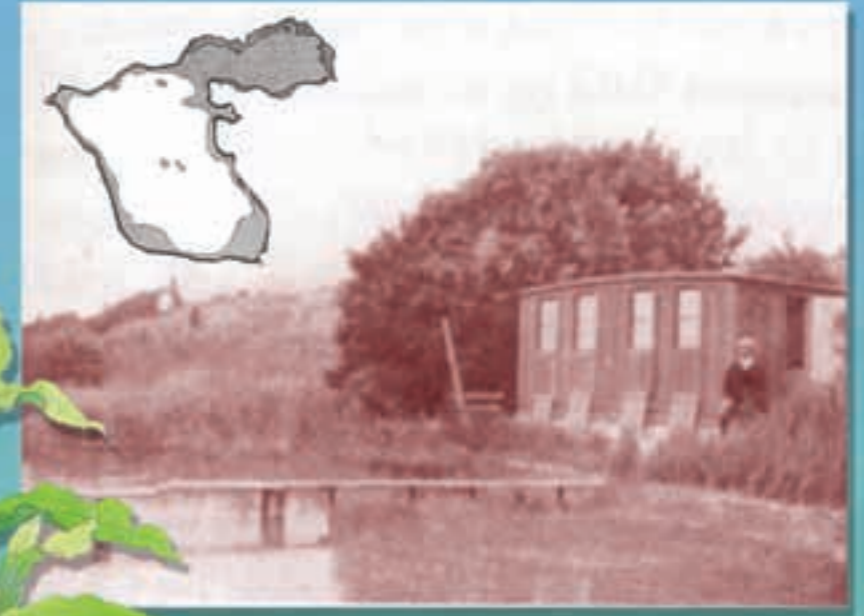
The above map from 1911 shows the vegetation in the entire Store Kalv down to a depth of 8 meters in the main basin.

At the time, 33 species of submarine plants were registered in the lake, including 18 species of phanerogams and 10 species of stonewort.

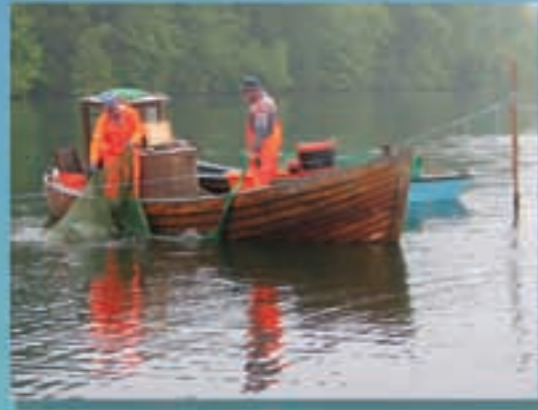
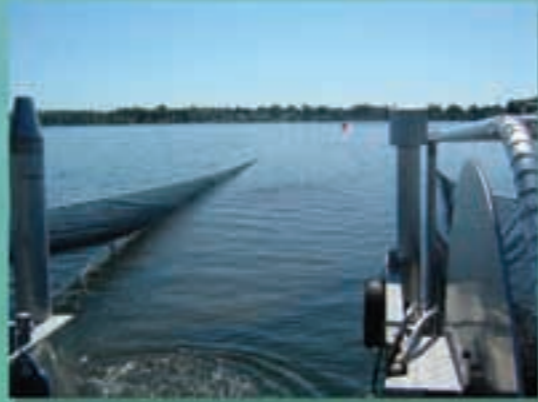
Up to 42 pound nets have every year been placed along the shores of Lake Furesø. At the lower end of the lake fishing also took place by a 1 km seine which was capable of fishing in the entire water column.

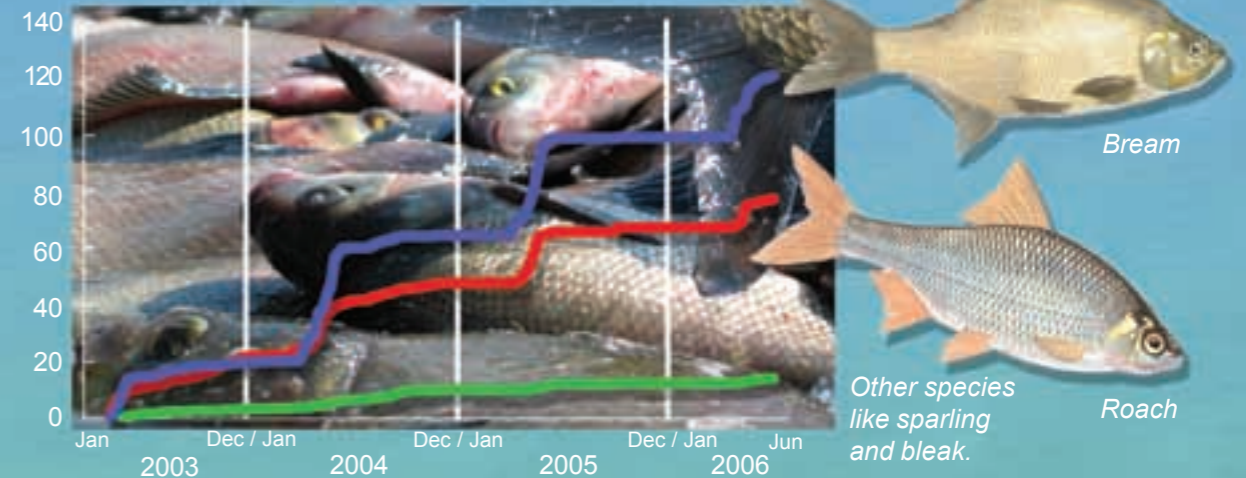
Summarized Catch in Tons distributed on Species

212.5 tons of fish have been caught during the project period. These are distributed on 77 tons of roach, 121 tons of bream, and 14 tons of other species. Around 140 tons have been fished by pound net and 72 tons by seine.

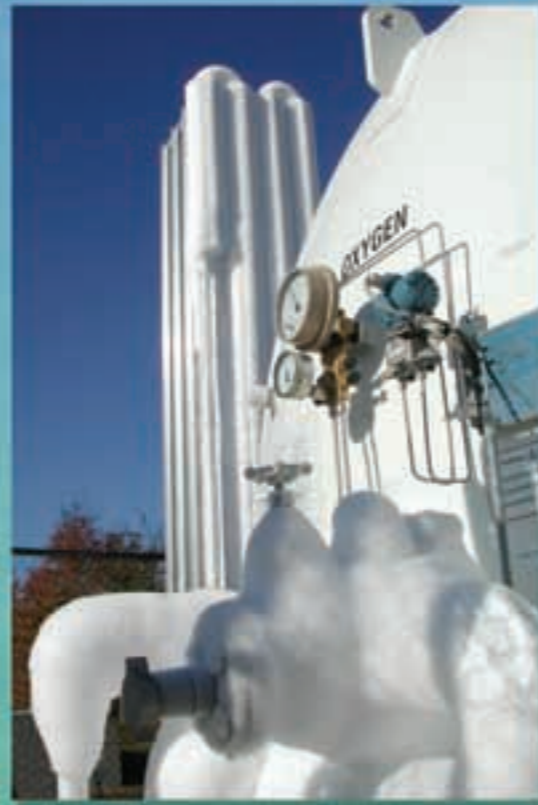
On land the oxygen system consists of a tank in which the oxygen is kept under liquid form under high pressure and at a temperature of minus 170°C. Three pipes go from the tank into the deepest places of the lake. The huge ice formations on the tank are due to the fact that the oxygen must be transformed into air before being led through the pipes.

In order to better adjust the discharge, pure oxygen is used instead of atmospheric air, which only contains 21% oxygen.

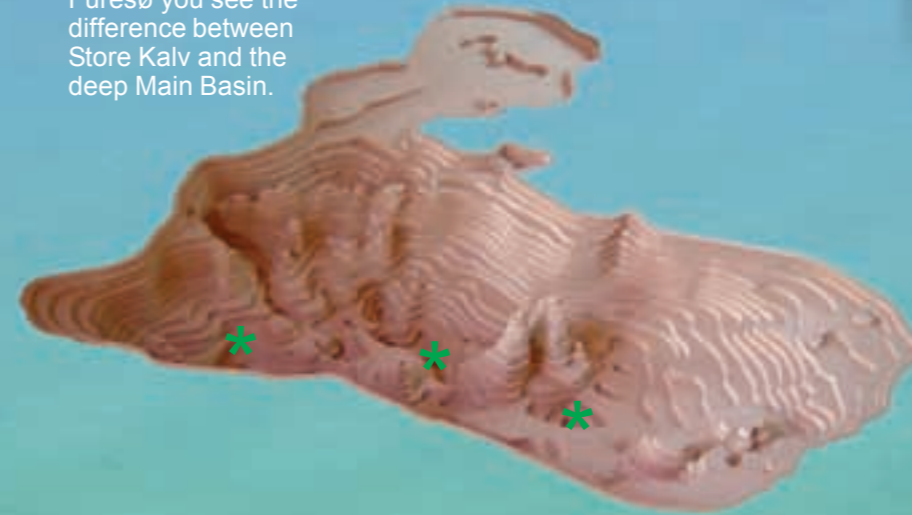
On this model of Lake Furesø you see the difference between Store Kalv and the deep Main Basin.

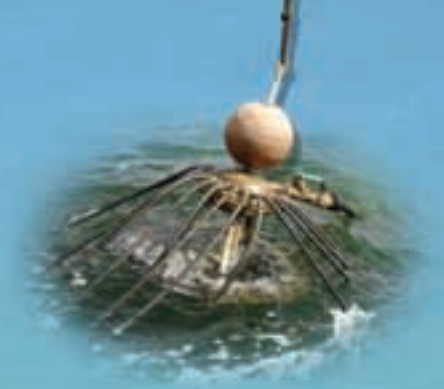
The plant on land is connected to three oxygen diffusers, which are placed at the deepest places in Lake Furesø, more than 30 meters below the surface. Each of the diffusers is equipped with a number of pipes, each of a length of 100 meters and perforated by thousands of holes which are so small that the oxygen bubbles are immediately dissolved into the bottom water.

The discharge is currently adjusted so that the desired oxygen concentration of around 4 mg oxygen / liter in the bottom water is maintained. From 2003 to 2006 the daily discharge of oxygen has been reduced from approx. 5 tons to around 2 tons.

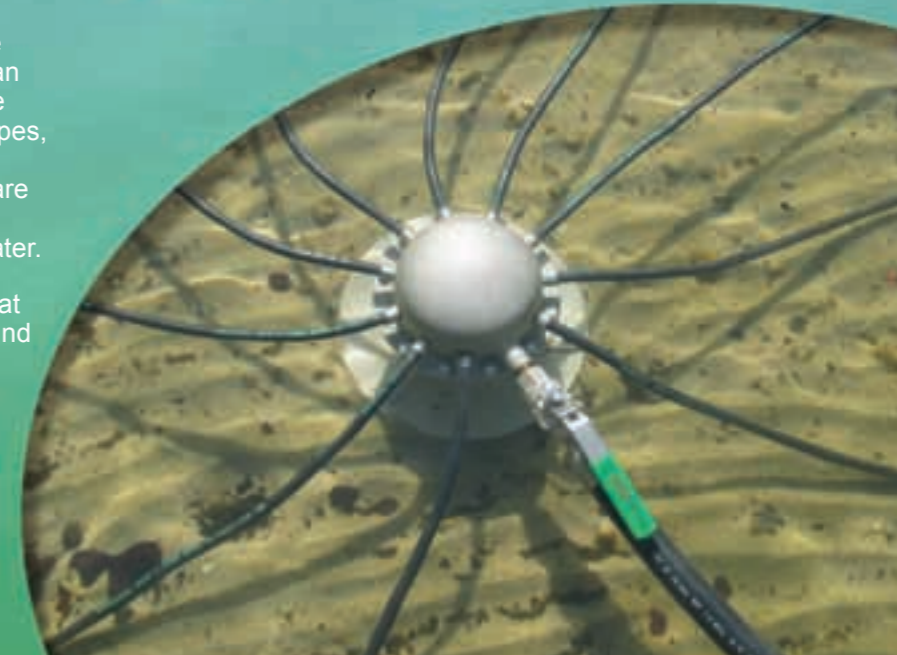
During winter when no oxygen is led out, sludge is caught in the diffusers and the pipes. Therefore they are taken up to the surface every spring for cleaning.

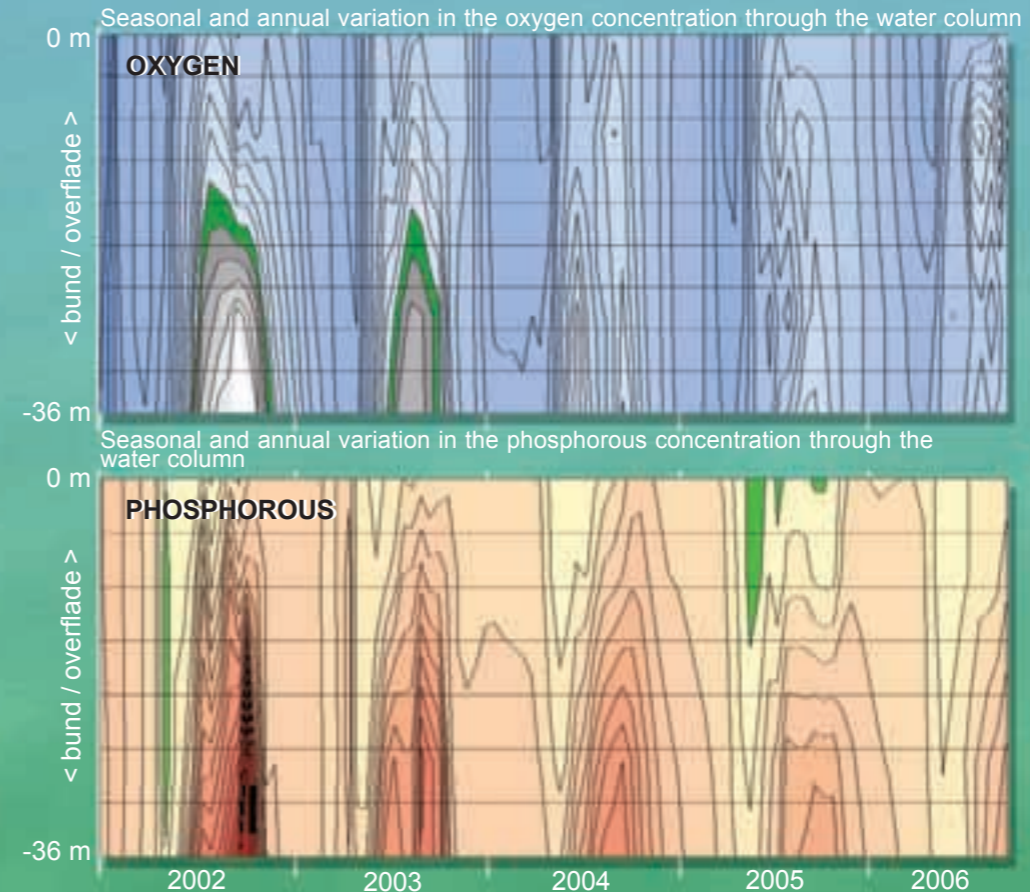
Thanks to continuous measurements carried out in Lake Furesø, it is possible to make the below graphical presentations, which show a clear connection between the concentrations of oxygen and phosphorous in the bottom water. The white and grey colours in the first presentation show that during the summer periods before the project started in 2003 there was almost no oxygen deeper than 15 meters below the water surface. The deep red colours in the lower presentation show that during the same period huge quantities of phosphorous were liberated from the bottom of the lake. 2003 was the year the oxidation plant was commissioned, therefore the impact of the oxidation on the liberation of phosphorous has only really been observed from 2004.
